SPECIAL REPORT M-256
January 1979
Evaluation and Introduction of
New Construction Materials and Techniques

INVESTIGATION OF MATERIALS FOR WATERPROOFING
LEAKY CONCRETE AMMUNITION-STORAGE
BUNKERS FROM THE INSIDE

by
Stanley M. Kanarowski

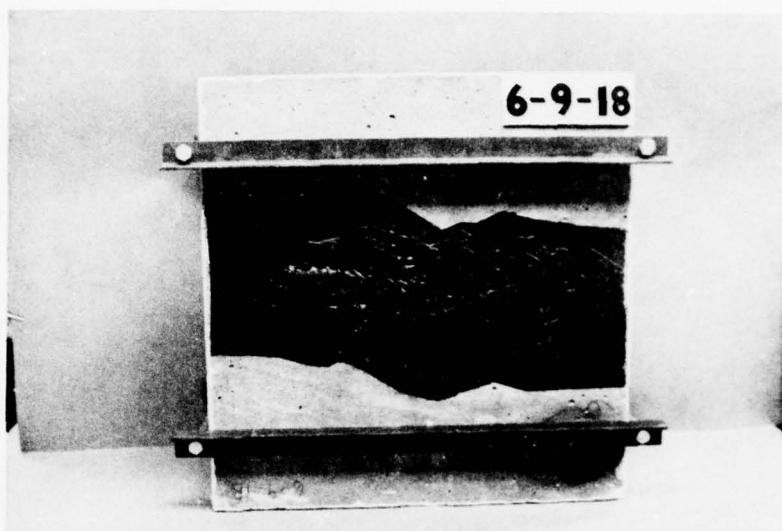
Figure 7. Tremco 50V and primer sprayed in 5/16-in. (7.94-mm) crack (specimen 6).

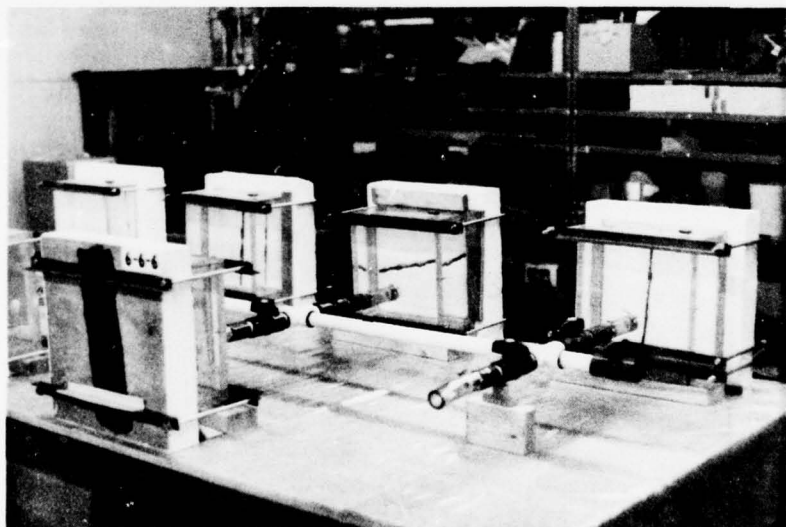
Figure 12. Surface of test specimens 2, 4, 6, and 8 exposed to hydrostatic pressure -- note severity of cracks.

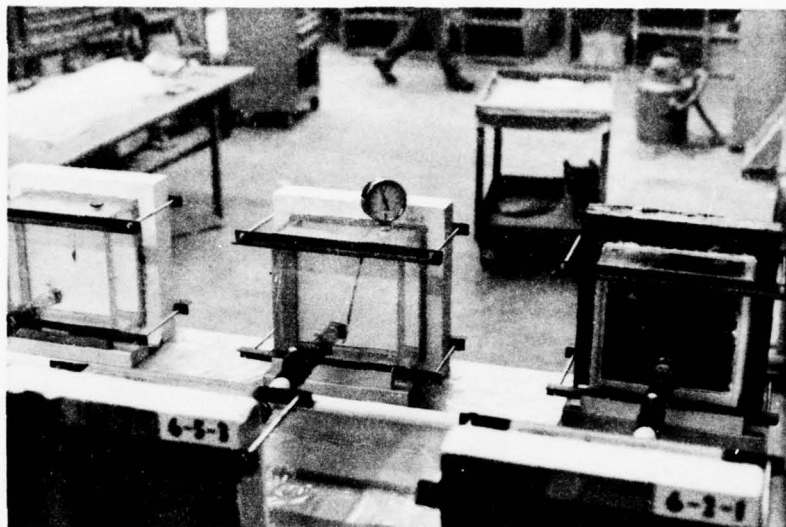
Figure 13. Surface of test specimens 7 and 3 (left and center) which were exposed to hydrostatic pressure -- hairline cracks.

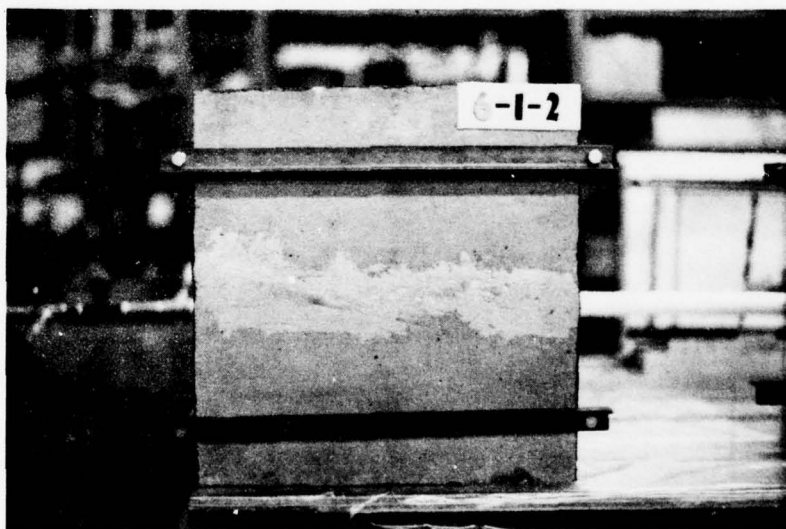
Figure 14. Specimen 1 -- Mameco Vulkem Sealant No. 116 (urethane, 1-comp).

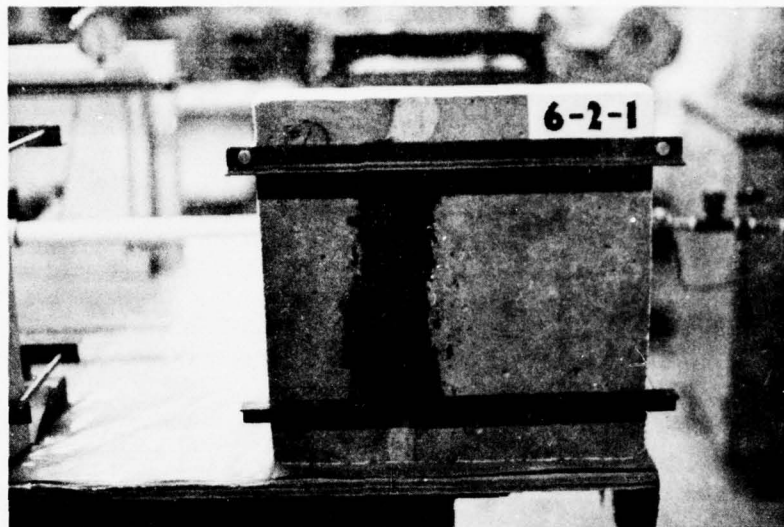
Figure 15. Specimen 2 -- Tremco 50V, no primer (tar/urethane, 2-comp).

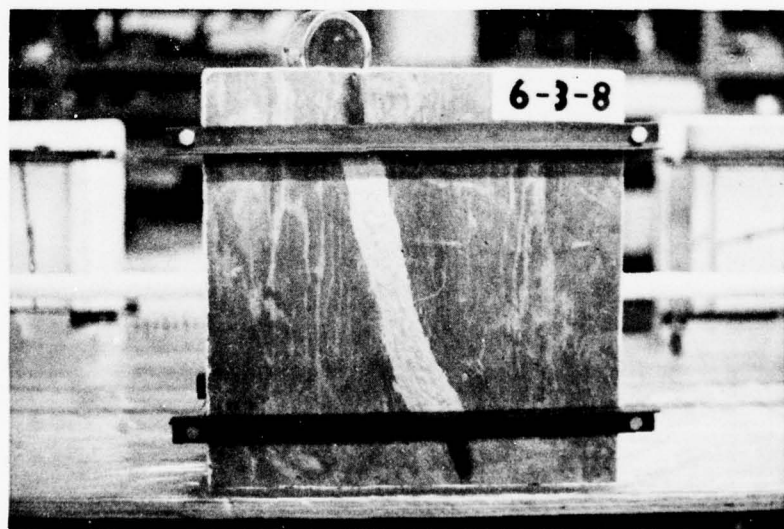
Figure 16. Specimen 3 -- Carbolite 225 (epoxy/polysulfide, 2-comp).

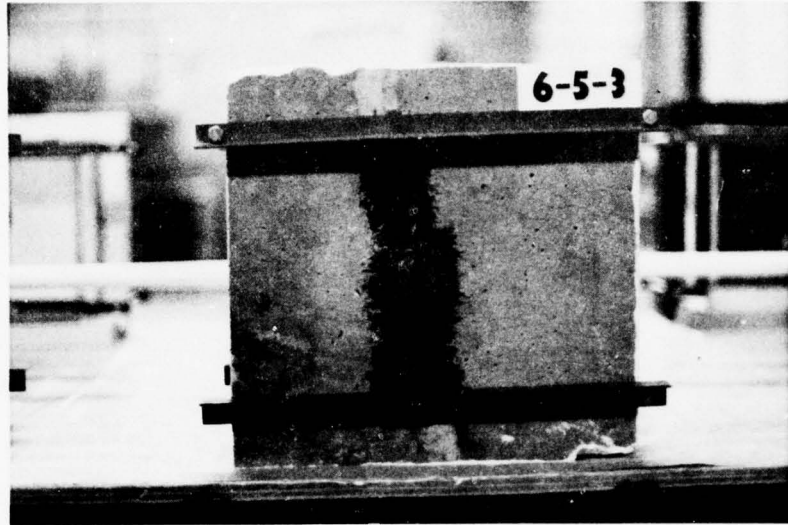
Figure 17. Specimen 4 -- Atlas Neobon Trowel Cement and primer (neoprene base, 2-comp).

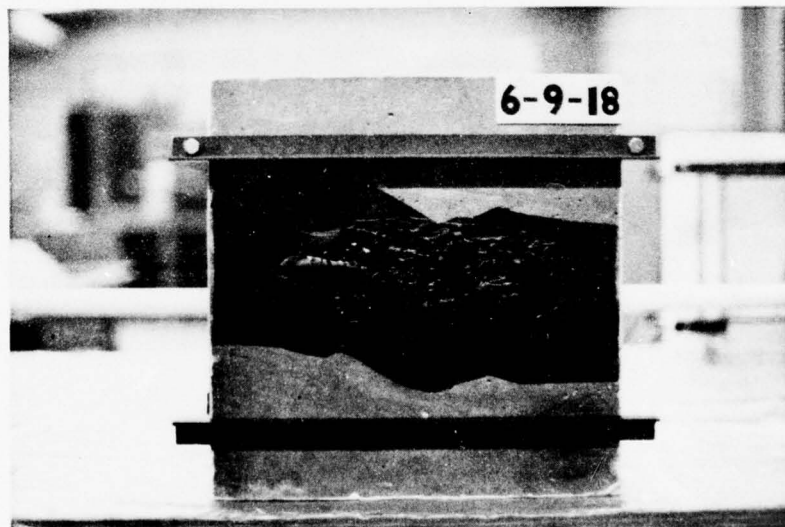
Figure 18. Specimen 6 -- Tremco 50V and primer, sprayed (tar/urethane, 2-comp).

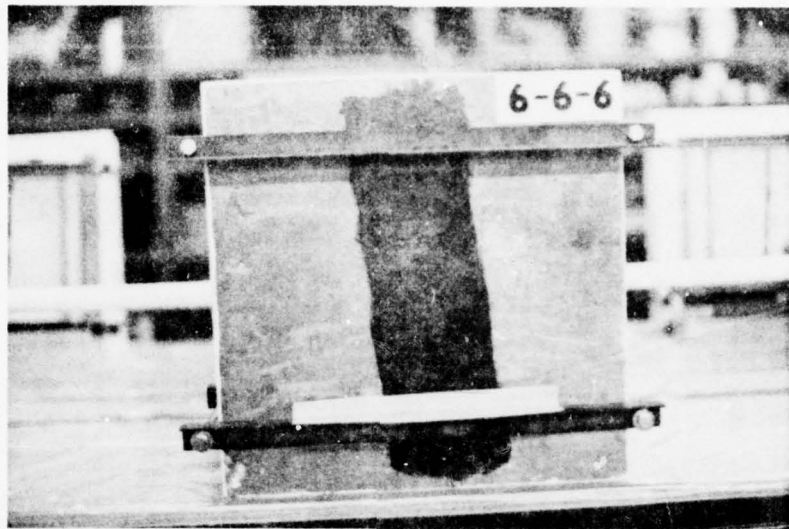
All specimens (Table 3) were then subjected to the hydrostatic tests. Numbers 5, 7, and 8 developed leaks. Number 5 failed on the third day and number 7 in less than 1 day. Number 8 developed some seepage on each side of the crack during the first day and also began to swell. However, since the leak subsided, this specimen was continued in the test; the swelling became larger and spread over a greater area. One area of No. 8 swelled to a height of 11/16 in. (17.5 mm) after 30 days of testing; it failed completely 3 days later.

Figure 19. Specimen 7 -- Protecto Wrap CA1200 Mastic and primer (coal tar/resin, 1-comp).

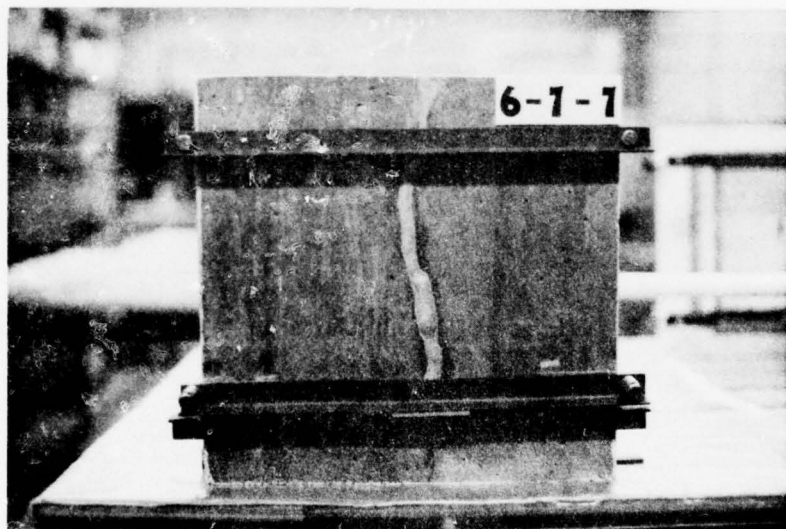
Figure 20. Specimen 8 -- GE Silicone SCS2004 and primer (silicone, 1-comp).
